ANNUAL REPORT FOR 2008

Smith Creek Mitigation Site

New Hanover County

Project No. 8.2250109

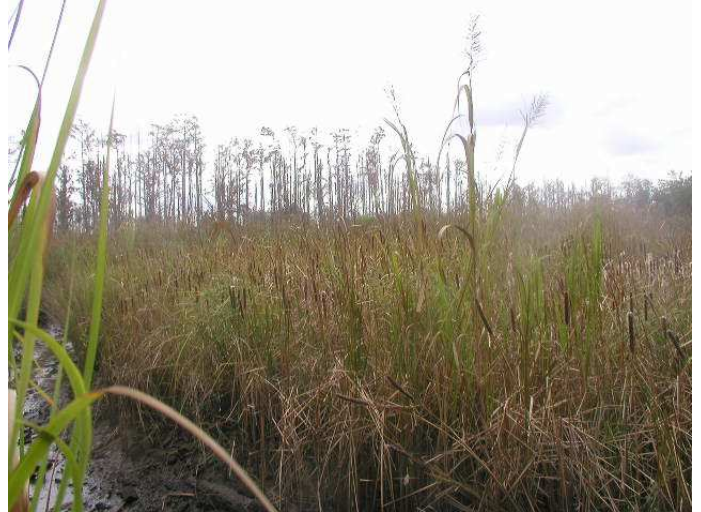
Photo 4

Since, the 2006 monitoring evaluation photos 4, 5, and 6 had to be taken from down in the site, instead of, on the bridge due to traffic being turned onto the Smith Creek Parkway.

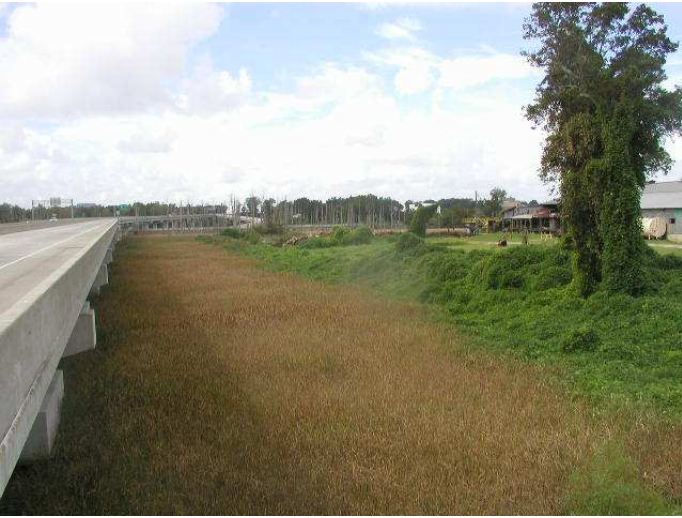
Photo 7

As seen in Photo 7, kudzu is starting to encroach into the site. Division Roadside personnel treated the kudzu in October 2008.
